NASA WG3 MMOD Protection Summary

Interagency Space Debris Coordination Committee (IADC)

May 2012

IT 29-1: Hypervelocity Facility CNSA-NASA Cross-Calibration

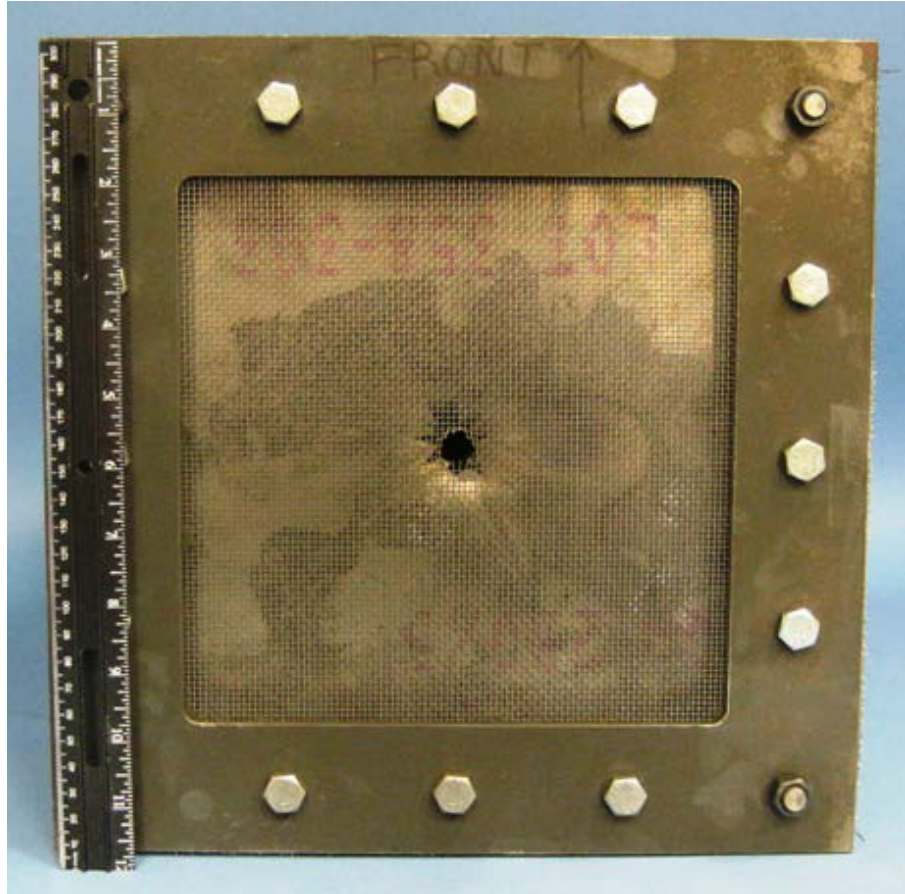
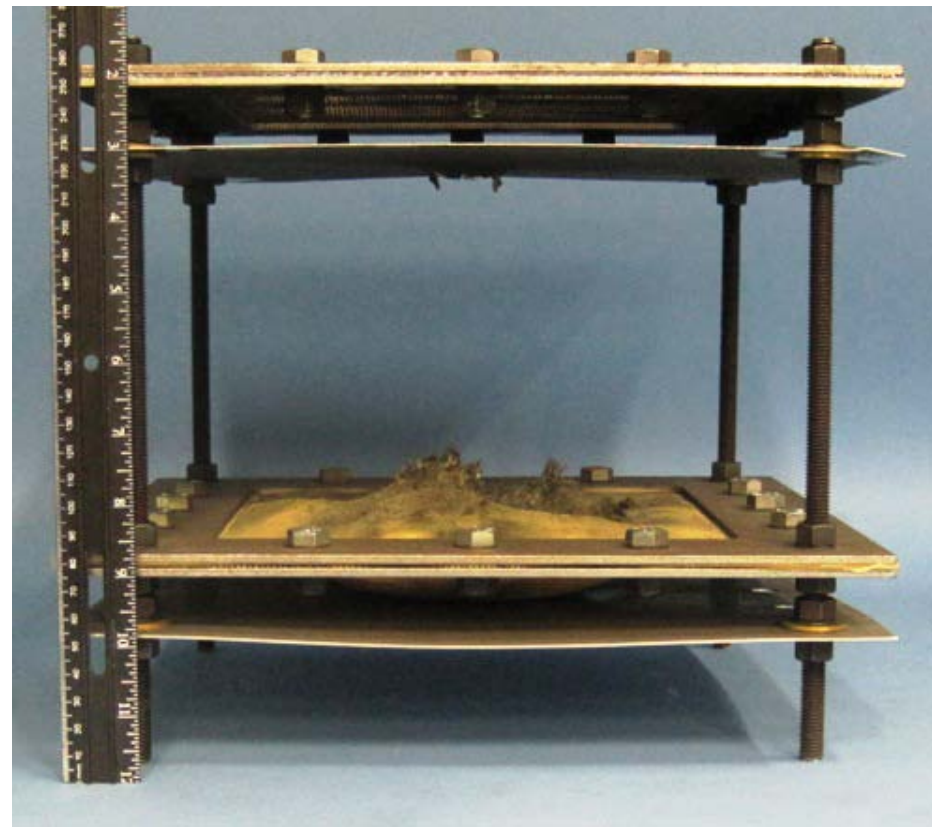
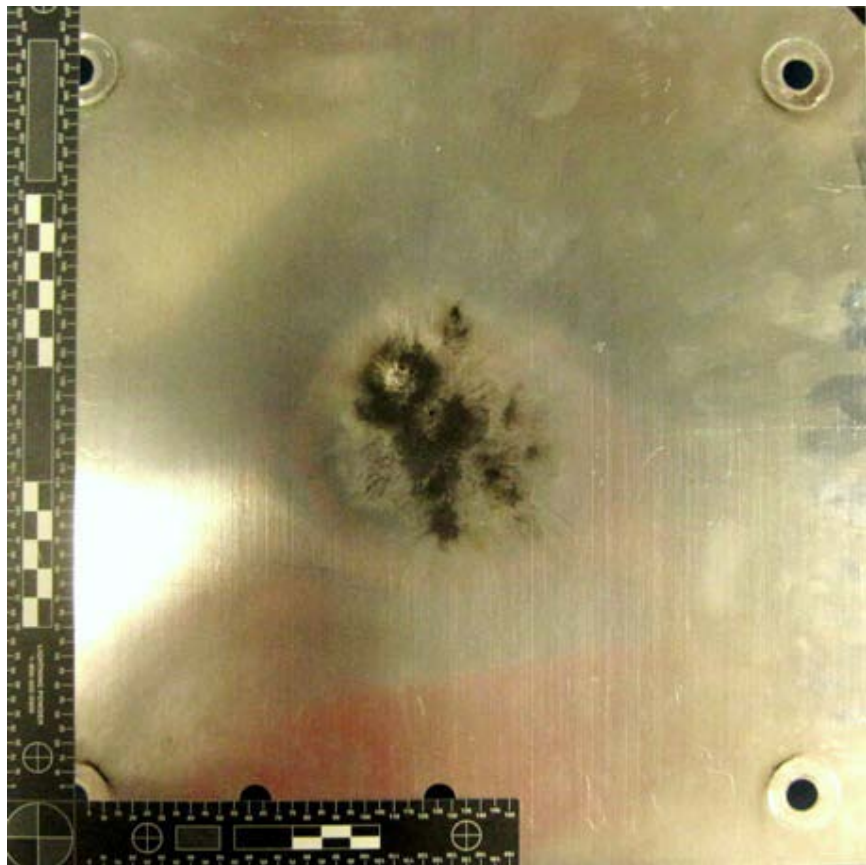
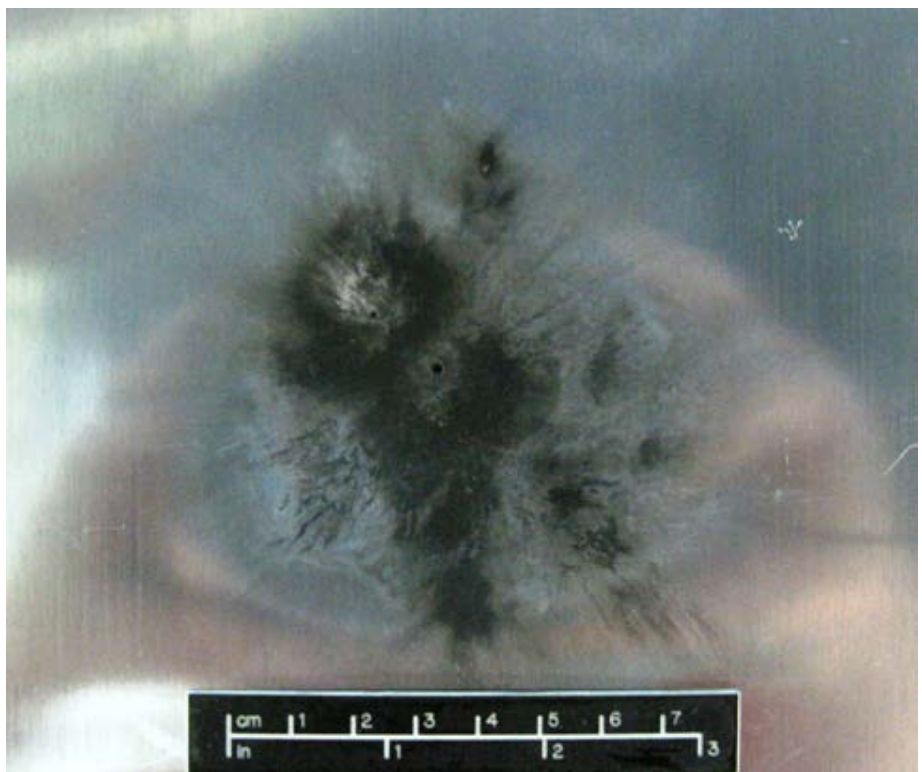
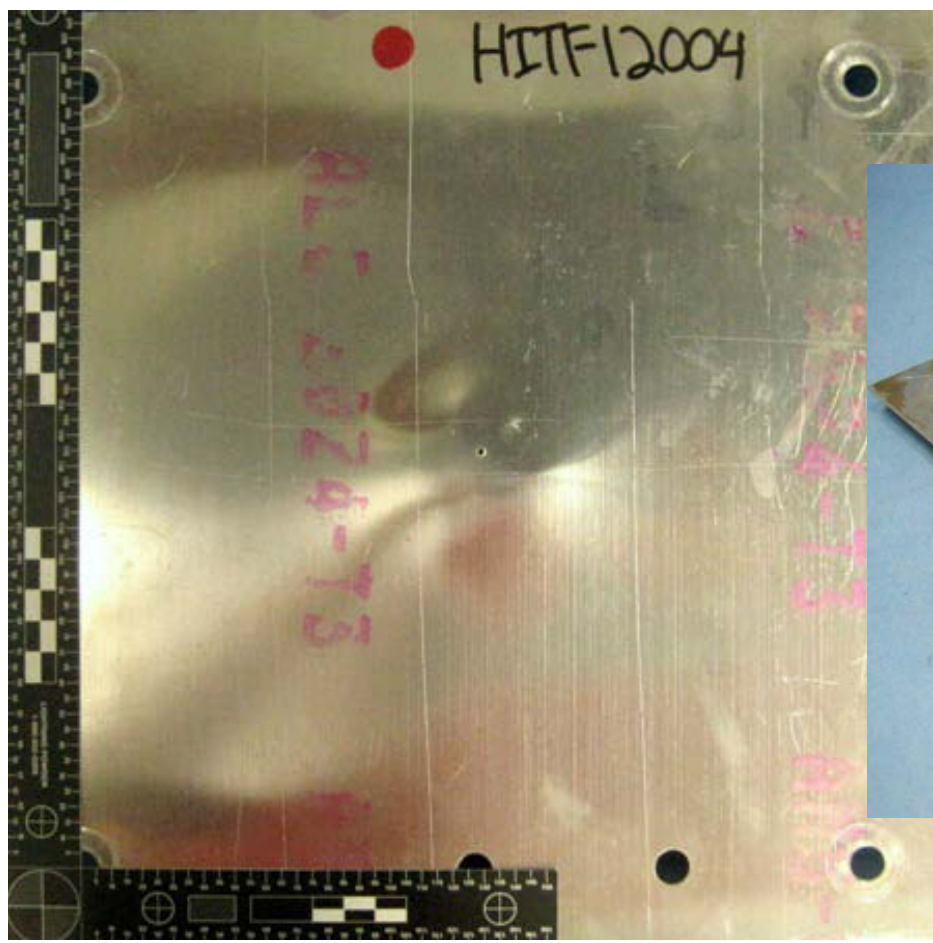
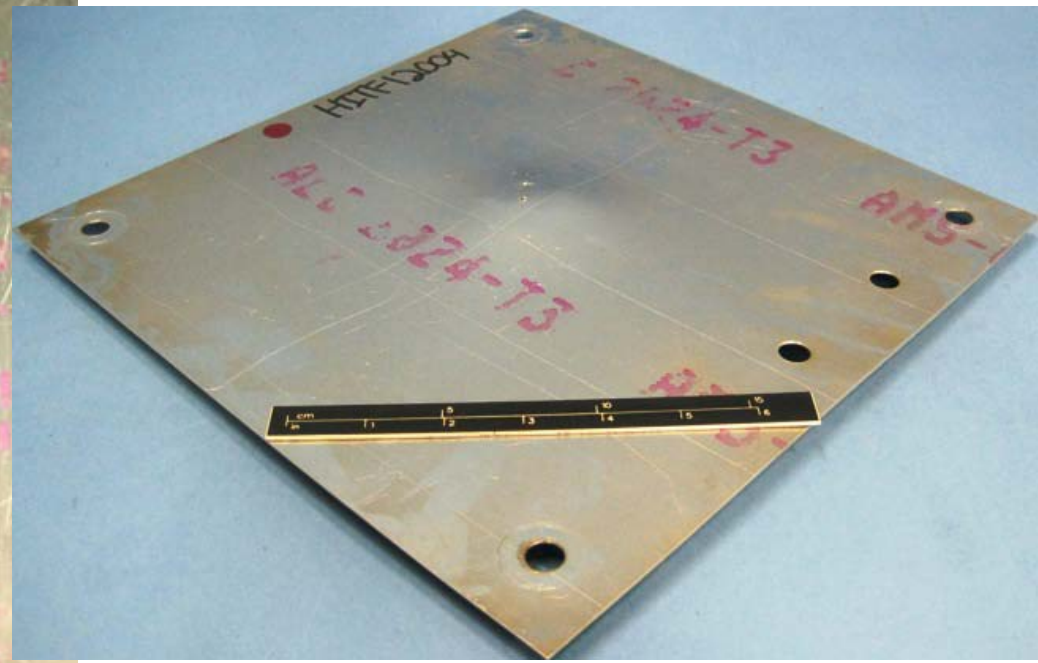
HITF-12004, Mesh Double-Bumper 0.651g/cm³

#4. HITF-12004	6.4mm Al, 0.37407g, 6.91 km/s, 0 deg impact angle	Mesh Double Bumper shield 0.65 g/cm ²	1 st layer: 14.6 x 13.2mm hole 2 nd layer: 25.5 x 15.3mm hole 3 rd layer (last layer of Kevlar): two perforations in 65 x 41 mm area, with largest hole 53 x 44mm	Bulge, dish with two small perforations (fail) Impacted area 87 x 70mm diameter, bulge is 98 x 95mm diameter by 4.9mm high, largest perforation is 1.7mm x 1.6mm diameter
